**NORTH FORK AMERICAN RIVER
OLD GEORGETOWN BRIDGE
DEBRIS ASSESSMENT**

**State Highway 49
Placer & El Dorado Counties, California**

October 30, 2020

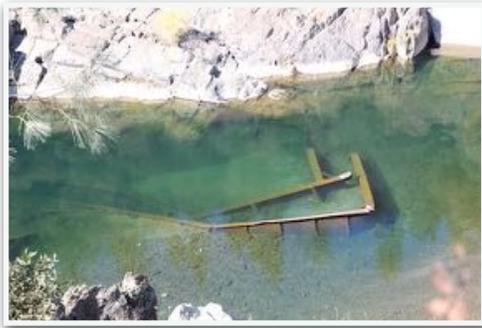
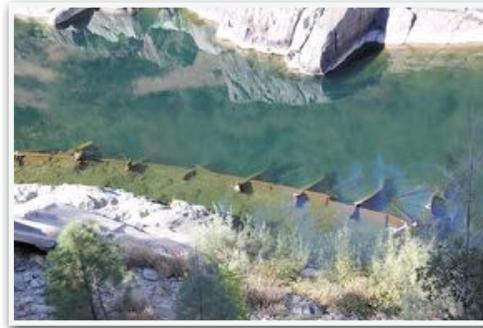
The structural steel located in the river consists of different sizes. The main girders (2) are reported to be I-beams 10 feet in height, with flanges approximately 16 inch, top and bottom, with nominal thickness of approximately 1 inch. Each main girder had a continuous length of approximately 340 feet.

Cross girders that originally supported the concrete road deck are estimated to be 10" x4" by 5/8" thick. Each cross girder is approximately 26 feet in length. Total number observed is difficult to determine as pieces have broken away, or are buried, but approximately 30-32 would be consistent with original construction.

Two main cross girder supports, which rested on the two bridge piers, are larger than typical cross deck girders, size roughly 3 feet in web height and 1 foot web depth. Likely 1 inch nominal thickness similar to main girders. These two girders are approximately 26 feet long.

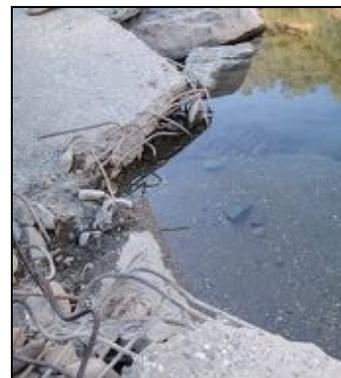
Figure 10

The surrounding site is sensitive ecologically. Movement and demolition of materials will require special consideration. The river canyon banks are steep and contain foliage. The fire road on south side is unimproved dirt. Smaller trails from the main fire road down the bank sides to the water exist, but are steep and dangerous. Heavy use in this area is subject to erosion.

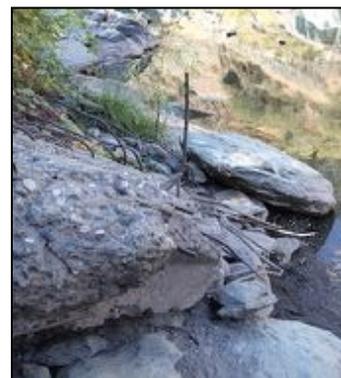
Figure 11

In addition to the twisted and jagged structural steel girder sections partially or completely submerged, large concrete sections of old highway are resting on both banks. These concrete slabs have a large amount of exposed and protruding rebar that poses a serious hazard to recreation area users.

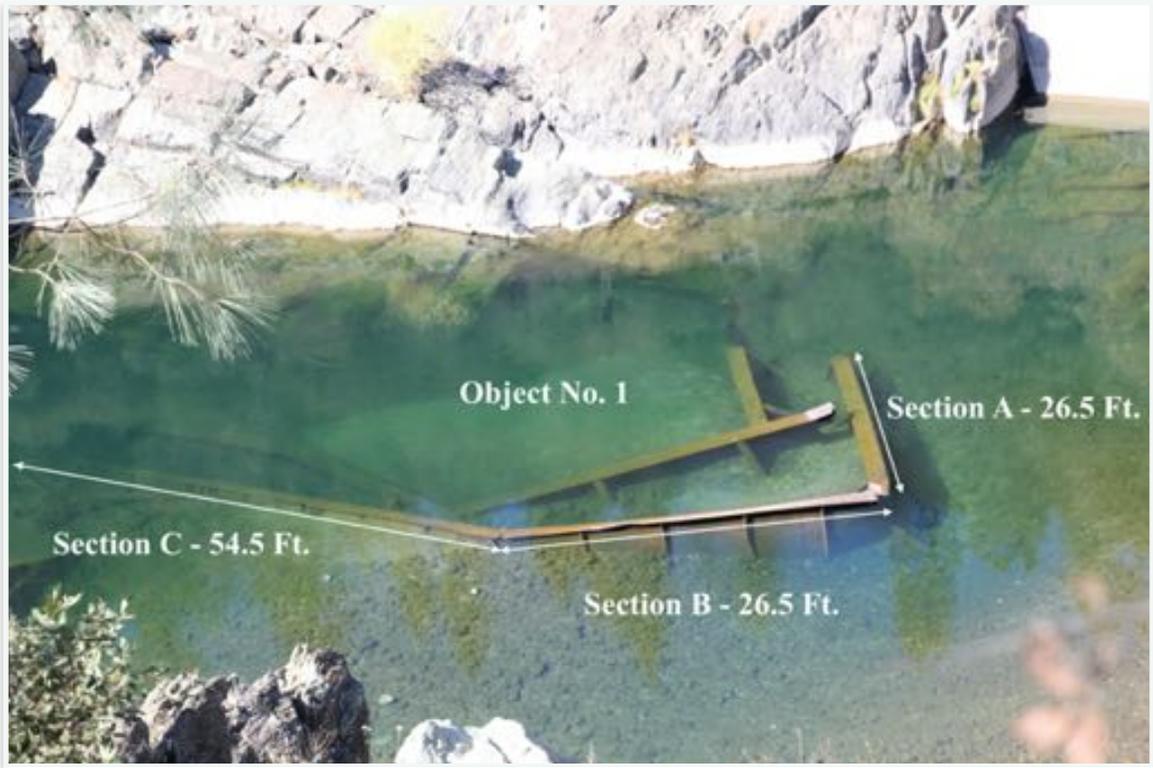
Figure 13: Shows Object No. 1 Girder Section Length Measurements

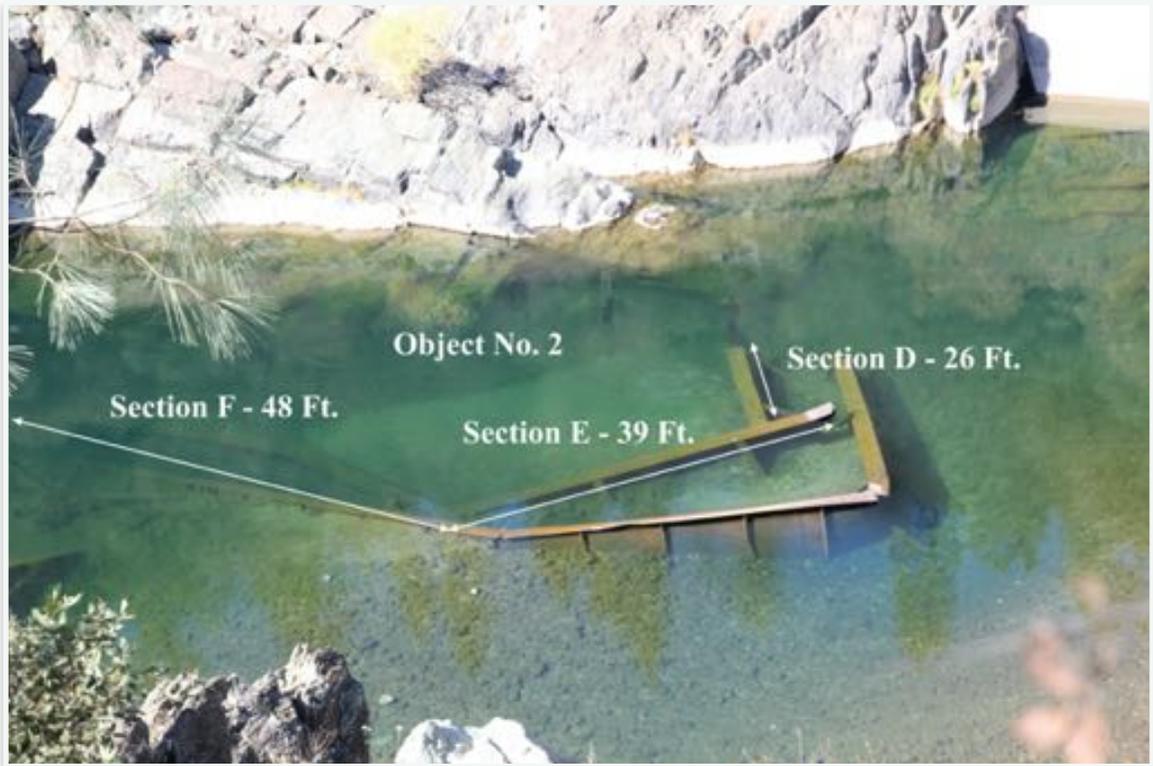
Figure 14: Shows Object No. 2 Girder Section Length Measurements

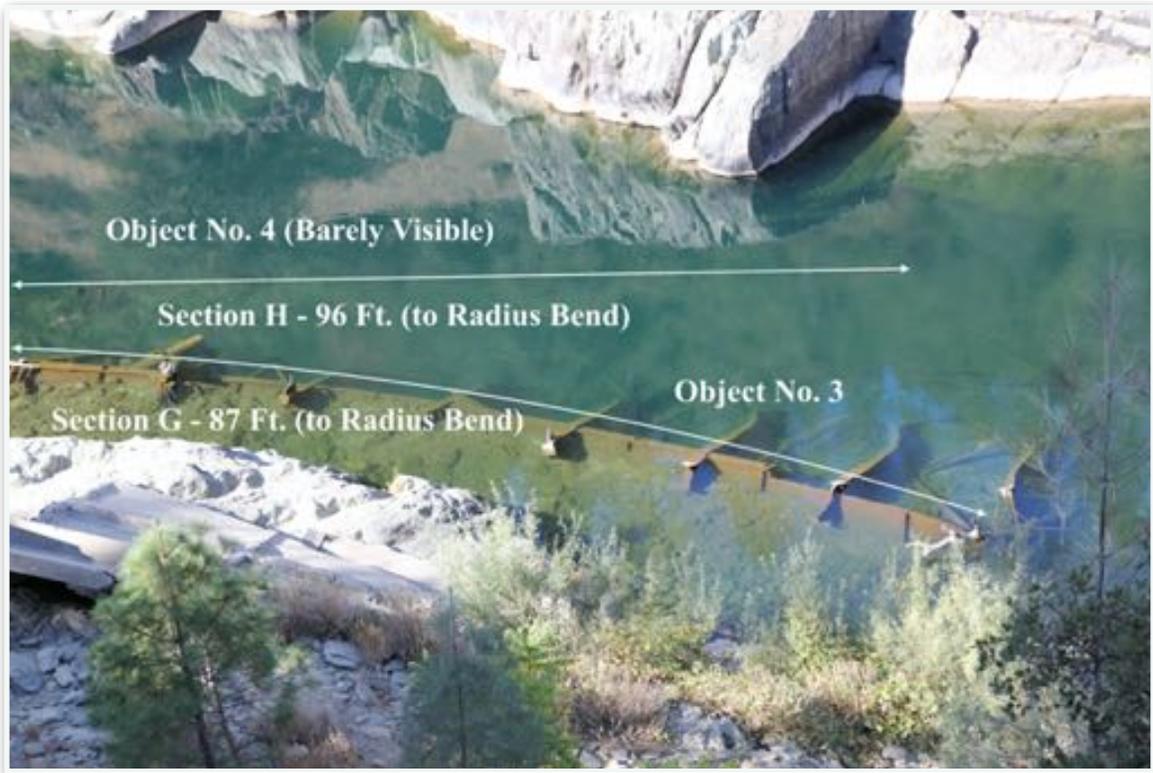
Object No. 3 was easily accessed by the divers on the surface, with no diving equipment required. Therefore, no underwater video was obtained. The Object No. 3 measurements are included in the annotated site photos, which are incorporated into the survey video.

Figure 15: Shows Object No. 3 & 4 Girder Section Length Measurements
