**NORTH FORK AMERICAN RIVER
OLD GEORGETOWN BRIDGE
DEBRIS ASSESSMENT**

**State Highway 49
Placer & El Dorado Counties, California**

October 30, 2020

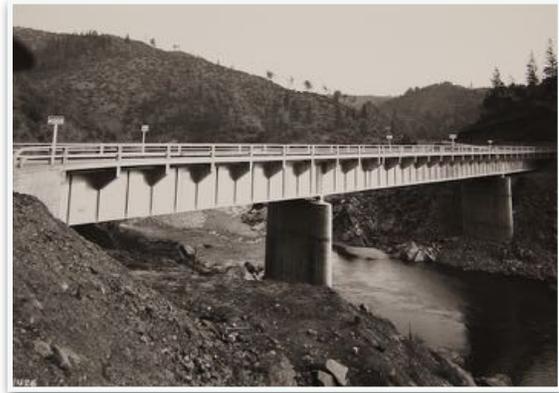
Figure 1

The concrete bridge decking was broken into numerous sections and carried down the river. Several large pieces are scattered along both sides of the river bank below the current bridge. These large sections of concrete contain a large amount of protruding rebar.

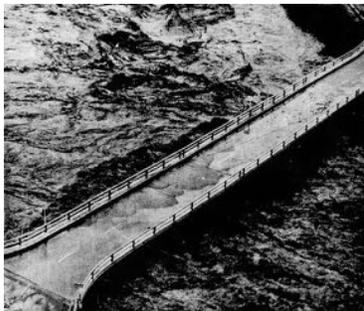
Figure 5

From historical observations during the flooding and bridge collapse, several phases occurred during failure. The downstream side main girder failed first and began collapsing. Bridge decking (concrete) began to break up and lift, followed by the failure of the center main girder. The center section began to twist, followed by failure of the upstream main girder. The entire span then collapsed and was carried several hundred yards downstream to their resting points. It appears that during the failure that the main girders folded during collapse or upon striking the river bottom. Therefore, the objects in this survey appear as (4) items.
